TECHNICAL REPORT REMR-CO-3

**CASE HISTORIES OF CORPS BREAKWATER
AND JETTY STRUCTURES**

Report 2

SOUTH ATLANTIC DIVISION

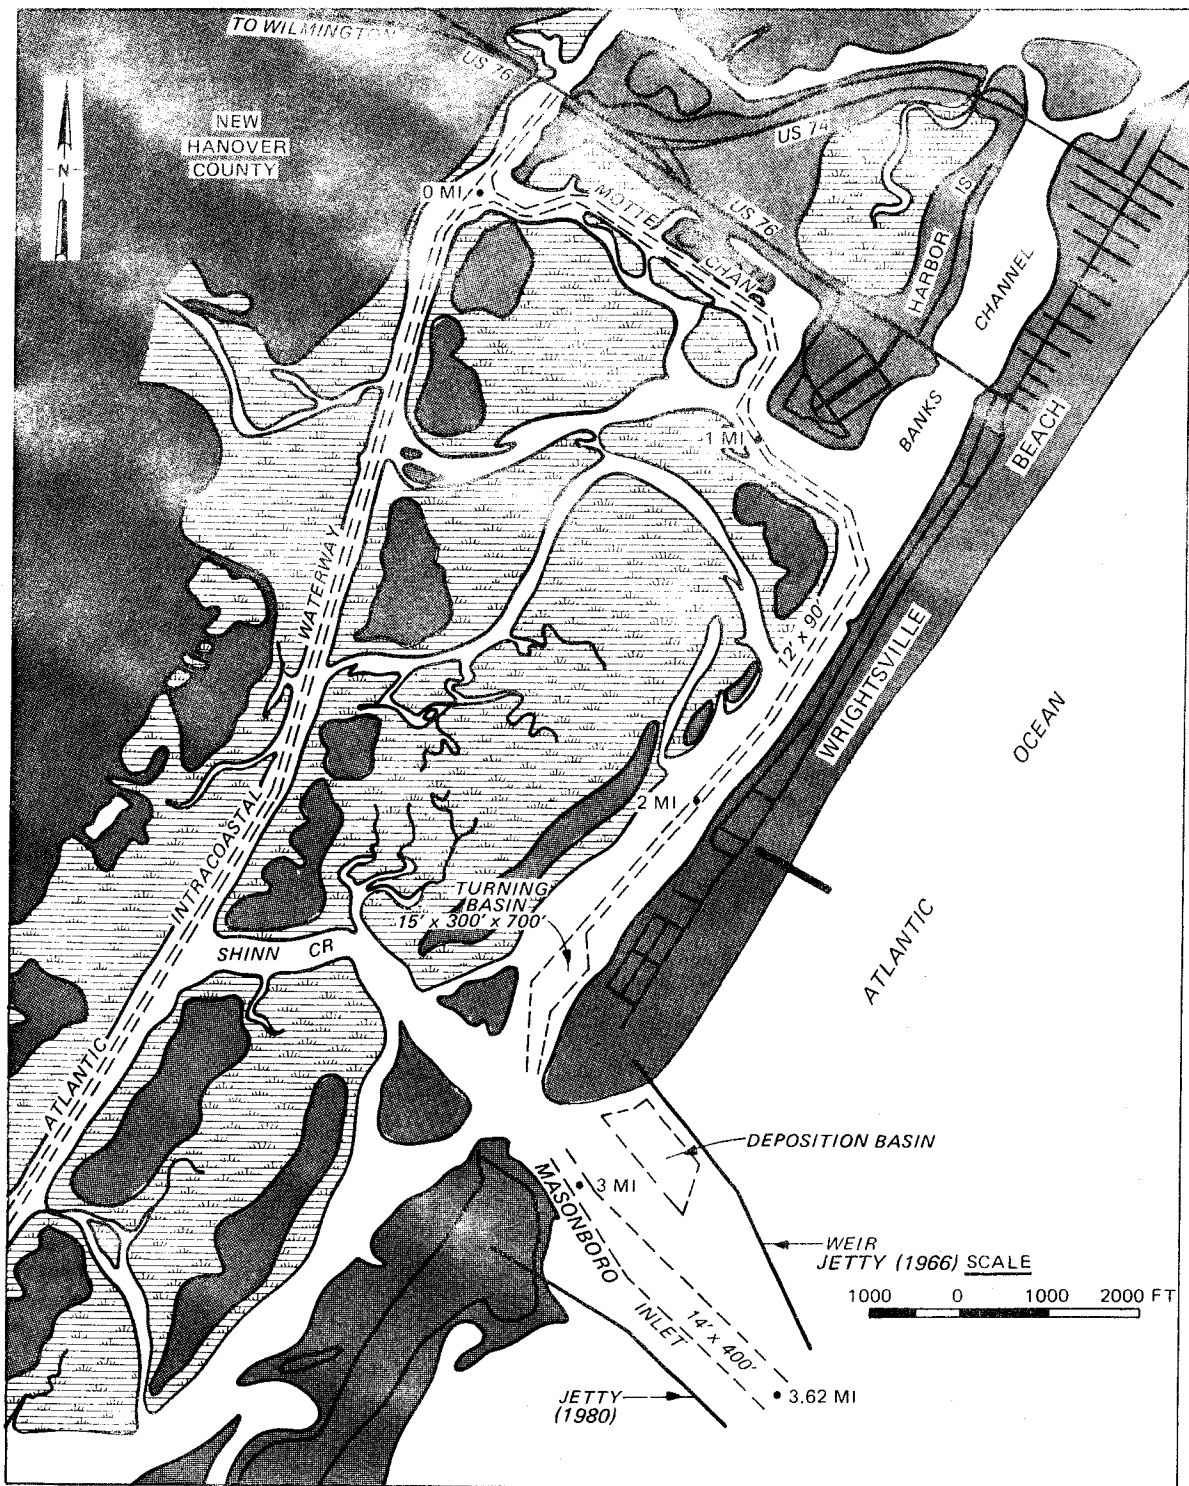
Figure 10. Masonboro Inlet, North Carolina

1985	Presently, the south jetty is in good condition; whereas, the north jetty, which was constructed of smaller size armor stone, is in need of repair work in several areas showing localized armor stone damage.

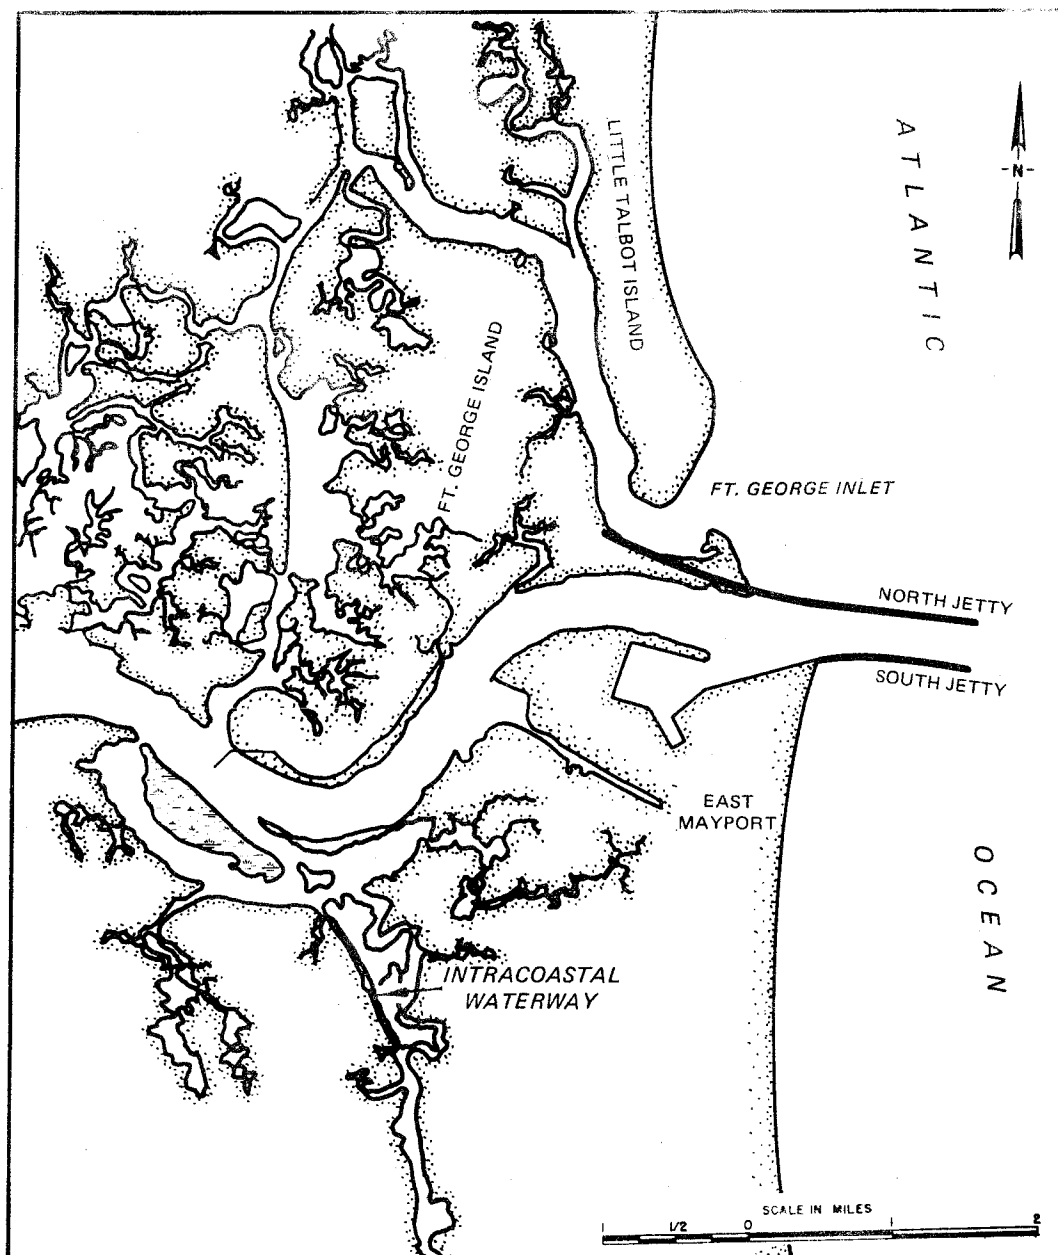
Figure 22. Jacksonville Harbor jetties, Florida

1897- 1928	<p>During this period both jetties were raised above mhw (+4.9 ft), numerous repairs were made to the jetties, the north jetty was extended seaward 2,070 ft, and the channel depth was increased to -30 ft mlw. The method of jetty construction by this time was to place the stone directly on the natural bottom with the smaller stone placed at the bottom and the larger stone placed above mlw. The size of the largest armor stone used increased during this time from a typical size of 4 to 7 tons. Figure 23b shows a cross section of the north jetty taken shortly after work was completed during 1923. This design section consisted of a 10-ft-wide crest at</p>

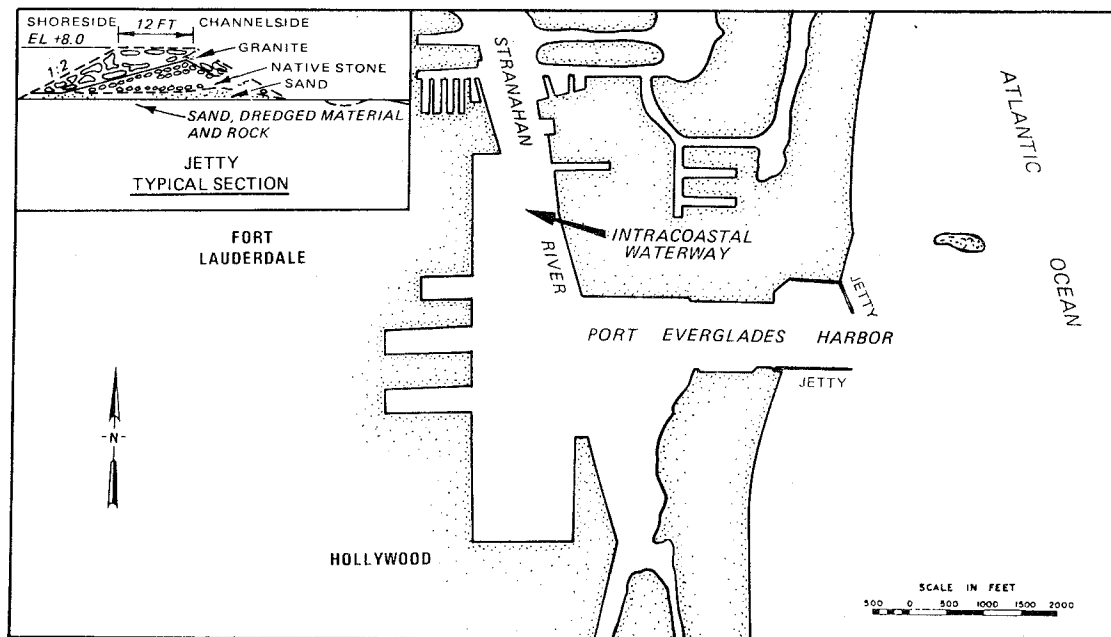
Figure 35. Port Everglades Harbor, Hollywood, Florida

Date(s)	Construction and Rehabilitation History
1928	Jetties were constructed (Figure 35) by local interests using native Florida limestone which ranged in weight from 300 lb to 8 tons (average of 2 tons). The design elevation, width, and side slopes were +6 ft mlw, 12 ft, and 1V:1.5H, respectively.
1931	The structure came under Corps jurisdiction in 1930. A survey of the existing structure showed elevations of from +10 to 0 ft mlw at the shoreward and seaward ends, respectively. Storm and wave action was believed to be major cause of subsidence at the seaward end. Seaward ends of jetties were in approximately 12 ft of water, and a 35-ft-deep channel passed between the jetties. The jetties were approximately 1,200 ft apart at their shoreward ends and converged at their seaward ends to a distance of 550 ft. The north and south jetties were approximately 1,250 and 1,025 ft long, respectively. Natural rock strata underlying the jetty and inlet areas exists at -10 to -15 ft mlw.

1932	Repairs made to the jetties consisted of placement of 2- to 10-ton granite stone to a height of +6 ft mlw, a crest width of 12 ft, and side slopes of 1V:2H. In addition, some old stone (about 400 pieces each weighing 1,000 lb or more) was rehandled in the construction phase. Total estimated quantities of stone were 4,900 and 5,230 tons for the north and south jetties, respectively. Total cost of the repair was \$49,400.
1935	A field survey showed approximate lengths of 1,250 and 1,000 ft for the north and south jetties, respectively. Centerline elevations on the north jetty range from +10 to +5 ft mlw over the shoreward (old) 500 ft and from +4 to +8 ft mlw over the seaward (repaired) 750 ft. Centerline elevations on the south jetty range from +9 to +7.5 ft mlw over the shoreward (old) 300 ft and from +9 to +4 over the seaward 700 ft. The outer 100 ft of each jetty appeared to have subsided 1 to 2 ft from the design elevation of +6 ft mlw.

1939	The jetty survey showed no major changes in centerline elevations. The north jetty elevations were +12 to +8 ft mlw from 0 (shoreward end) to 300 ft, +8 to +4 ft mlw from 300 to 1,200 ft, and +6 to +3 ft mlw from 1,200 to 1,250 ft (seaward end). On the south jetty the elevations were +9 to +6 ft mlw from 0 (shoreward end) to 220 ft, +10 to +7 ft mlw from 220 to 830 ft, and +7 to +3 ft mlw from 830 to 1,000 ft (seaward end).
1940	Repairs to jetties consisted of raising the seaward portions, straightening the seaward end of the south jetty, and placement of a special head section. The repaired lengths were 1,280 and 980 for

Date(s)	Construction and Rehabilitation History
1940 (Cont)	the north and south jetties, respectively. The outer 990 ft and 450 ft of the north and south jetties were brought up to +8 ft mlw with a 12-ft crest and 1V:2H side slopes (Figure 35, inset). The head section of each jetty had a +15-ft mlw crest elevation, a 24-ft-diam crest, and 1V:2H side slopes radiating away from the crown. A total of 18,900 tons of 4- to 12-ton granite stone was placed. (Other work consisted of placing 750 tons of 25- to 150-lb chinking stone and handling of 1,200 pieces of old stone.) Total cost of the repairs was \$142,700.
1978- 1979	As part of harbor deepening improvements, the seaward 200 ft of the north jetty was realigned parallel to the entrance channel (Figure 35). The realignment allowed the channel width between the jetties to be increased from 300 to 450 ft. The estimated realignment cost was \$75,000.

1984- 1985	The inner ends of the jetties were repaired by rebuilding the armor stone layer with new and existing stone. To allow the jetties to be used as fishing piers, void spaces were chinked with smaller stone, and a layer of asphalt was piled on the crown. Prior to the repairs, the inner ends were in very poor condition with numerous void spaces while the remaining parts of the jetties were considered to be in satisfactory condition.

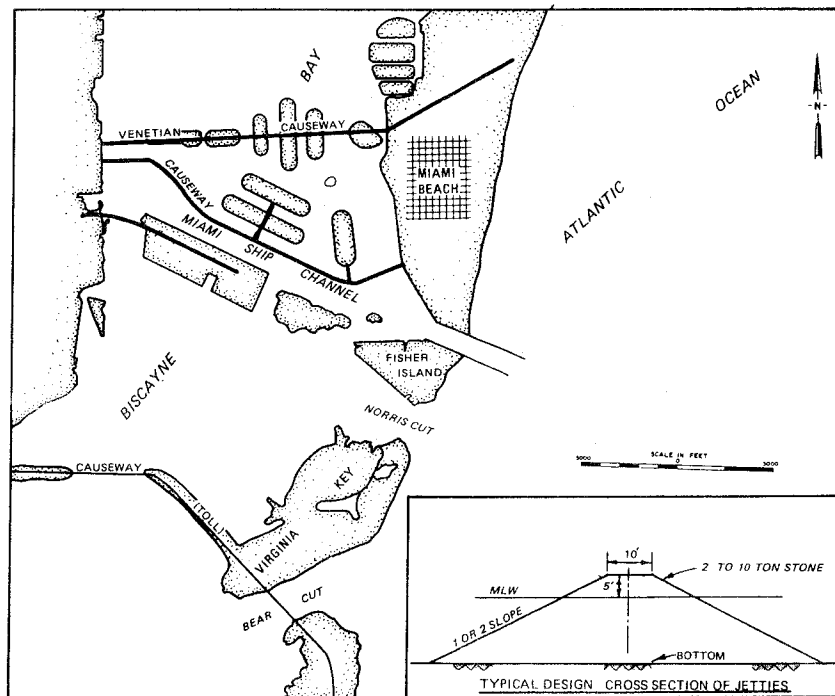
Figure 37. Miami Harbor, Florida

Date(s)	Construction and Rehabilitation History
1904- 1926	North and south jetties (Figure 37) 2,300 and 2,200 ft long, respectively, and 1,000 ft apart, were constructed to provide channel protection.
1927	Repairs were made to the north jetty and revetment. The jetty section was rebuilt to original dimensions with an elevation of +6 ft mlw, a crest width of 10 ft, and the side slopes were 1V:1.5H below mlw and 1V:1H above mlw. A total of 3,450 tons of granite was placed on the inner 700 ft of the jetty, and approximately 100 tons was recovered and used over the same section. Total cost of the repair was \$30,600. These repairs were required because the hurricane of September 1926 (passed over Miami) which resulted in several jetty breaches extending below mlw.
1928	The north and south jetties were extended seaward 1,350 and 600 ft, respectively. The jetty section consisted of a 5-ft crest width at +5 ft mlw with 1V:2H side slopes above mlw and 1V:1.5H below mlw. A total of 9,500 tons of Florida limestone was used as core stone and 37,300 tons of granite as capstone. Total cost of the extensions was \$208,000. A December survey of the original jetties (excluding the extensions) showed crest elevations ranging from +4 to -2 ft mlw. Approximately 100 ft of the old seaward ends were below mlw.

1985	Presently a 38-ft-deep by 400-ft-wide channel is maintained between the jetties. Except for the sand-tightened portion (1983), the jetties have not been repaired since 1934 and, although in poor condition, are still functioning properly.

1929	The jetties and north revetment were repaired. A total of 1,600 ft of the north jetty, 700 ft from its inner end, and 2,200 ft of the south jetty (exclusive of the 1928 extension) was repaired with granite stone to a crest width of 10 ft, an elevation of +5 ft mlw, and 1V:1H side slopes. Stone weighing 13,800 and 18,900 tons was used on the north and south jetties, respectively. The total cost of jetty repairs was \$181,000.
1931- 1932	Both jetties were surveyed in 1931 and 1932. Centerline elevations for the north jetty were from +9.5 to +4 ft mlw on the inner 2,300 ft and from -3 to +4.5 ft mlw on the outer 1,350 ft. (This section was damaged by storm waves during the survey period.) Centerline elevations for the south jetty varied from +4 to +8 ft mlw.
1933- 1934	Based on the previous survey of the jetties, repairs were made to bring the jetties up to the design section. The crest width was 10 ft, the crest elevation was +5 ft mlw, the side slopes were 1V:2H, and the granite stone varied from 2 to 10 tons. Several sections on the north jetty, totaling 2,100 ft, were repaired and a

Date(s)	Construction and Rehabilitation History
1933- 1934 (Cont)	700-ft section was repaired on the south jetty. A total of 45,000 tons of stone was placed, and additional stone was reset (200 pieces) at a total cost of \$232,000.
1950	A historical synopsis written at this time (which did not describe the condition of the jetties) stated that "the structure has served the purpose for which it was originally constructed." Repairs were made to the north revetment in 1948.
1983	At the shoreward end of the north jetty, a 1,200-ft-long section was made sand tight in conjunction with beach renourishment north of the jetty. The modification required raising the crest elevation, rebuilding damaged sections, and chinking voids with small stone (no details). This modification would inhibit the loss of sand placed adjacent to the jetty during, and subsequent to, beach nourishment. The cost of the modifications was \$608,000.

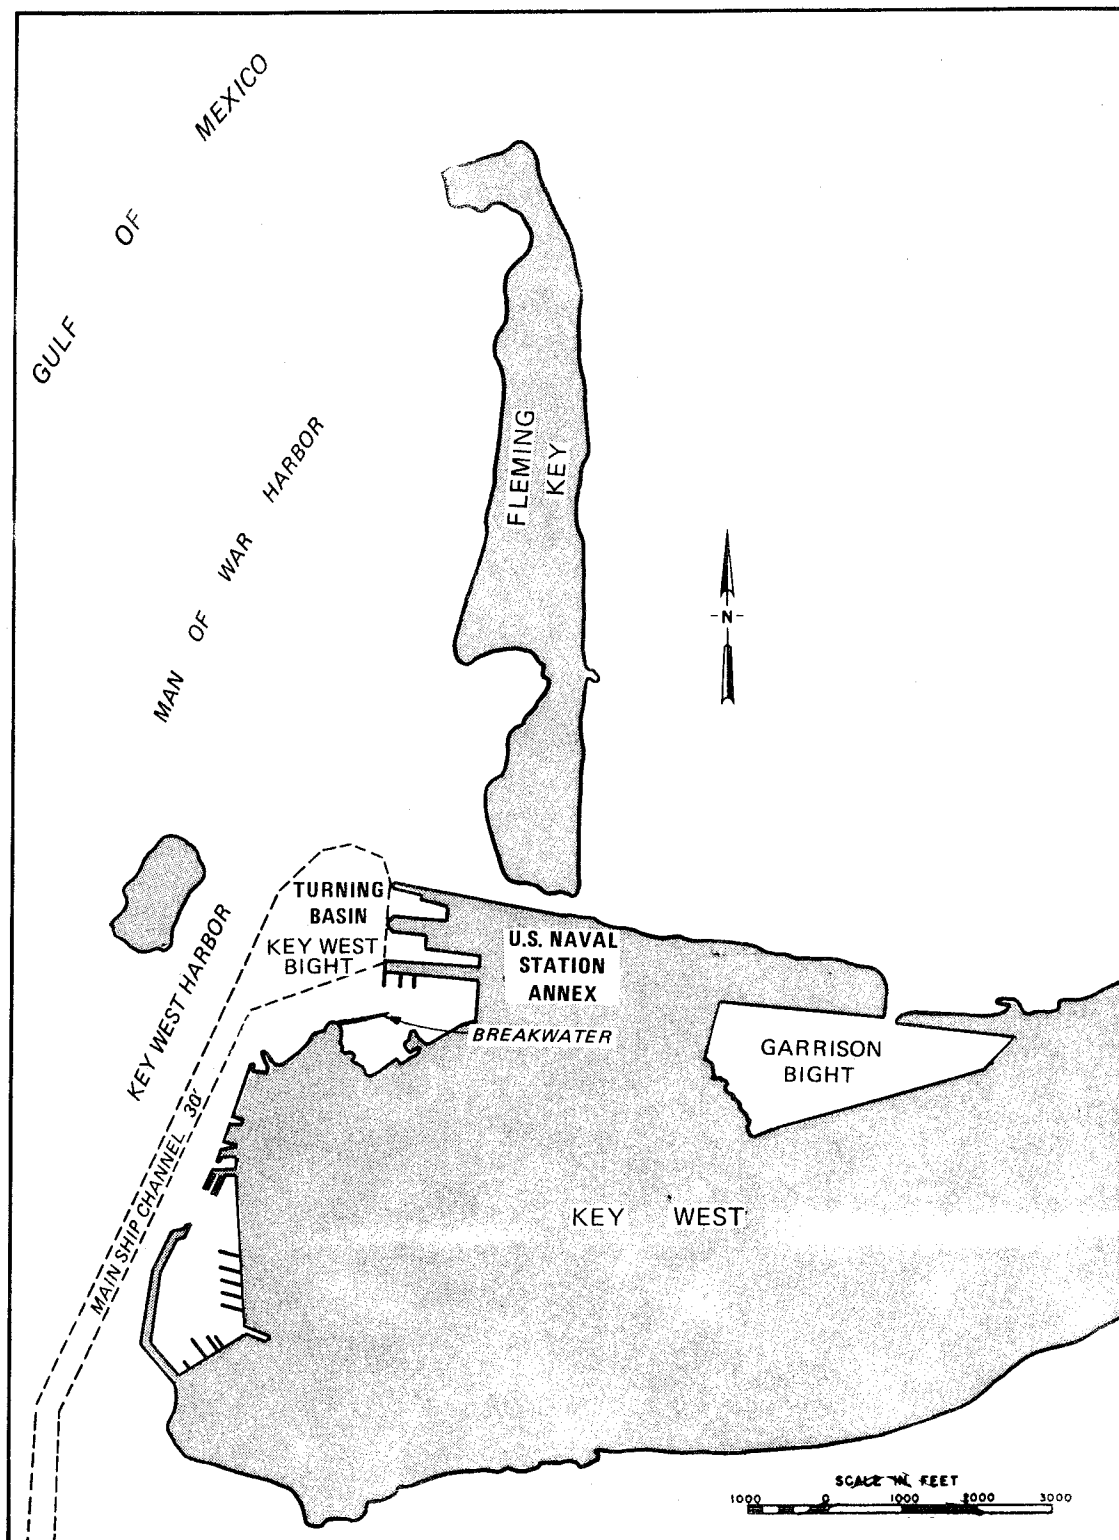
Figure 38. Key West Harbor, Florida

Date(s)	Construction and Rehabilitation History
1967	An 800-ft-long rubble-mound breakwater was constructed to provide harbor protection (Figure 38). The design section consisted of 1- to 12-in. core stone placed to an elevation of 0 ft mlw and overlaid with 2- to 6-ton capstone. The crest elevation was +6 ft mlw, the crest width was 10 ft, and the side slopes were 1V:1.5H. Estimated quantities were 15,100 and 18,800 tons for the foundation material and capstone, respectively. The breakwater design used Hudson's formula with an 8-ft wave height. To prevent potential overtopping, the crest elevation was selected based on a 3.2-ft, 4-sec wave (nonhurricane design wave). The cost of the breakwater plus necessary excavation was \$471,000.
1971	A portion of the breakwater was removed to aid in flushing of the harbor. The core stone removed was placed in a blanket 2 ft thick by 15 ft wide extending along one or each side of the breakwater as available stone would permit. The capstone removed was replaced to the existing design with the remainder placed in existing void spaces on the breakwater. The estimated cost of the modification was less than \$25,000.

1985	The breakwater has never been repaired and is presently in good condition.

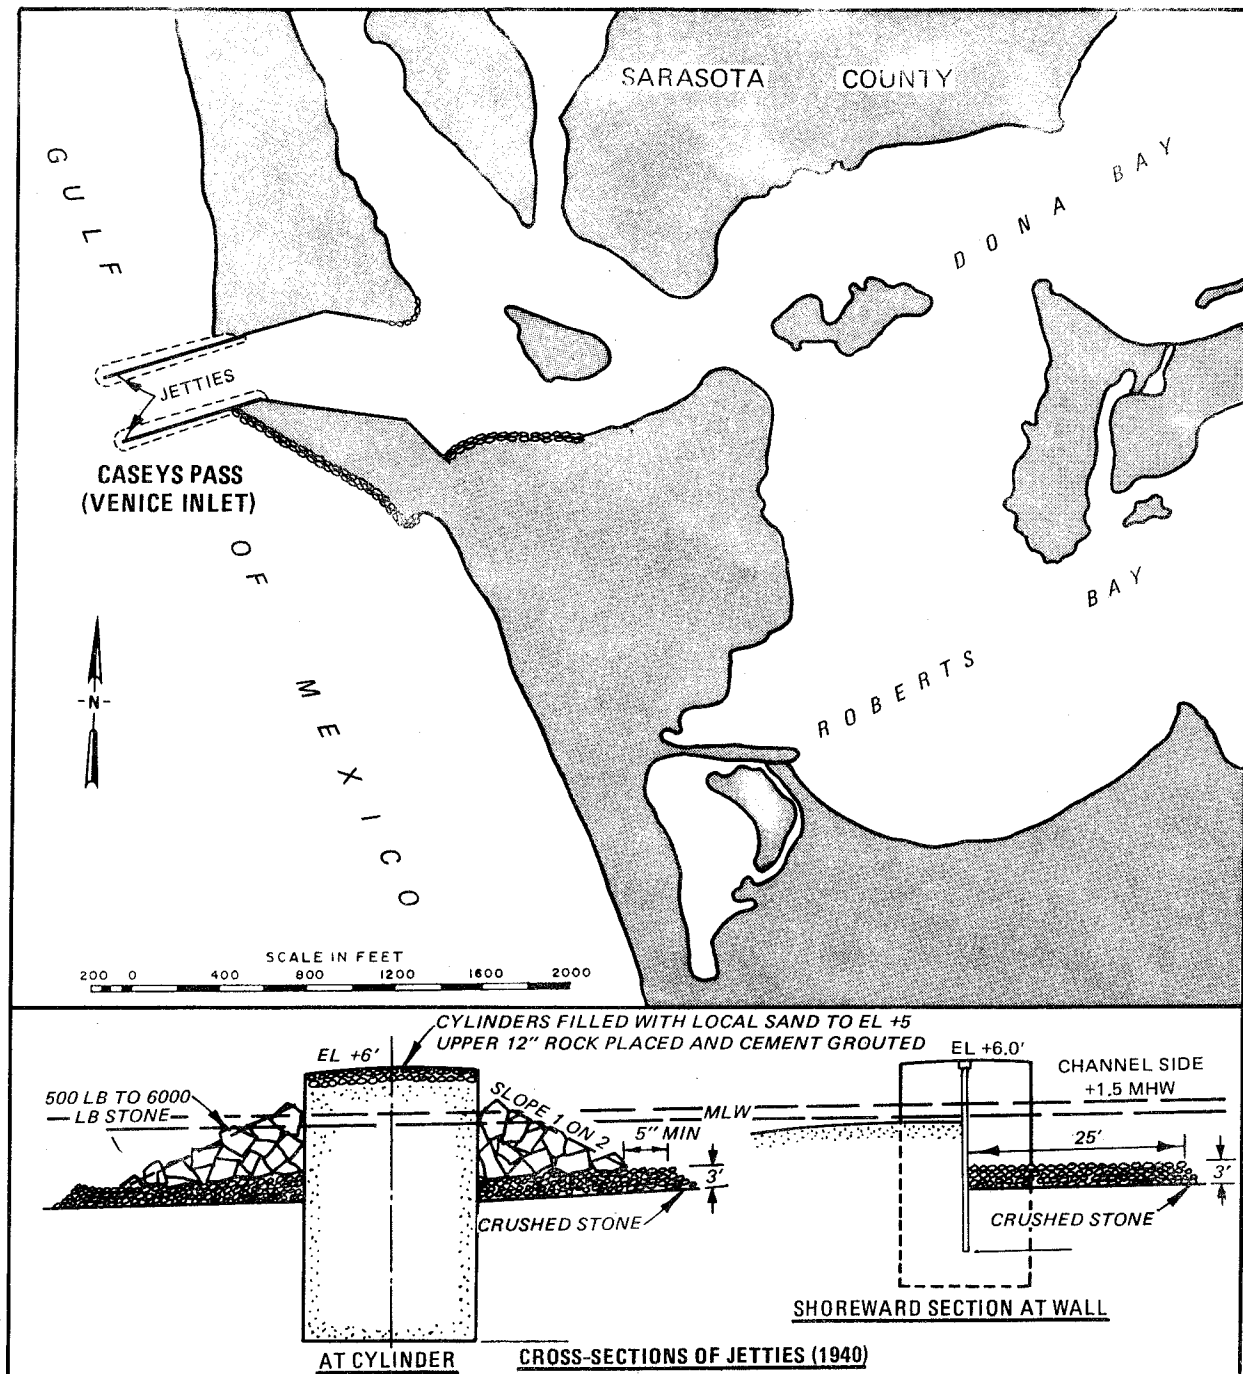
Figure 39. Casey's Pass, Florida

Date(s)	Construction and Rehabilitation History
1937	Two parallel, 660-ft-long steel sheet-pile jetties, spaced 300 ft apart, were constructed at this man-made inlet. Each jetty was composed of 19 cylinders (caissons), 15 to 20 ft in diameter and interconnected by linear sections of sheet pile (Figure 39). Each cylinder was backfilled with sand, and a stone and grout cap was placed in the upper foot. The crest elevation of the jetties was +6 ft mlw. A channel 100 ft wide and 8 ft deep was dredged through the inlet. The jetties were connected to the shore via creosoted wooden sheet-pile bulkheads. The total cost for the jetties and bulkheads was \$137,000.
1938- 1940	Limestone enrockments were placed along all exposed sections of the jetties (Figure 39). The section consisted of (total weights in parentheses) a crushed stone bedding layer (4,000 tons), followed by a layer of 50- to 200-lb (8,000-ton) stone, and covered with 500- to 6,000-lb (10,800-ton) stone placed on 1V:2H side slopes at an elevation of +2 ft mlw. The total cost of the improvements was \$122,000.

1950- 1951	Jetty surveys showed that the heads and seaward sides of the jetties needed repairs. The channel side of the north jetty needed repair because of the proximity of the channel causing scouring at the toe.
1955	Repairs were made to the seaward end of the south jetty which was in a "severely damaged" condition. A total of 650 tons of 3- to 6-ton cover stone was placed on a 2-ft-thick foundation blanket of 2- to 6-in. stone at a total cost of \$6,500. Repairs were also made to the collapsed concrete caps on the 1st and 8th caisson from its seaward end. Nearly 3/4 of the first caisson was severely damaged, and 3- to 6-ton cover stone was placed to +6 ft mlw with a 10-ft crown width. The upper 4 ft of the 8th caisson was filled with stone, and the upper foot of this was capped with concrete grout.
1963	Repairs to the concrete cylinder caps and jetty stone/rock revetments were made at a cost of \$30,000. At this time, the channel was dredged to a depth of -9 ft mlw. Along the exposed seaward sections, 3- to 6-ton capstone totaling 615 and 770 tons was placed on the north and south jetties, respectively, and approximately 20 capstones were reset. Several of the seaward cylinders were repaired. Their caps and sand were removed to -1 ft mlw, replaced with the broken pieces of the cap and 20- to 200-lb stone, and grouted with concrete throughout the upper 18 in. of stone.

Date(s)	Construction and Rehabilitation History
1968- 1969	<p>Visual examinations and detailed surveys showed the sheet-pile cylinders and walls to be in need of immediate repairs. Voids between the original concrete caps and the underlying sand existed in virtually all cylinders not repaired in 1963. Corrosion was the main cause of deterioration, with subsequent removal of sand from the cylinders because of wave and current action. Rehabilitation of the jetties was carried out in 1969 (Figure 40). The sheet-pile walls and cylinders (except the outer two on the north and outer one on the south) were removed down to +2 ft mlw, and the sand within the cylinders were removed to mlw. The existing concrete cap (broken into pieces less than 12 in. long) and 1- to 12-in. bedding stone were placed in the cylinders to +2 ft mlw. This was overlaid with 4- to 10-ton capstone (70 percent > 8 tons), with similar capstone placed along the connecting walls, to bring the structure to the original design elevation of +6 ft mlw with a crown width of 10 ft. Additional 4- to 10-ton capstone was placed, as needed, to bring the side slopes up to 1V:2H. On the outer 50 ft of the jetties, the side slopes were 1V:3H. Finally, asphaltic concrete was placed (Figure 40) on the jetties. This material was placed over the entire crown width down to mlw, and had 1V:1H side slopes. The design of the jetties used Hudson's formula with wave heights of 12 to 16 ft and wave periods of 7 to 9 sec.</p>

1978	<p>Repair to jetties consisted of resetting stone and adding 6- to 12-ton stone (75 percent > 10 ton) on the outer 200 ft of the jetties and 2- to 6-ton stone on the next 450 ft of the jetties as needed to solidify the structure.</p>
1985	<p>The jetties are in good condition except for their head sections which are in need of some repair.</p>

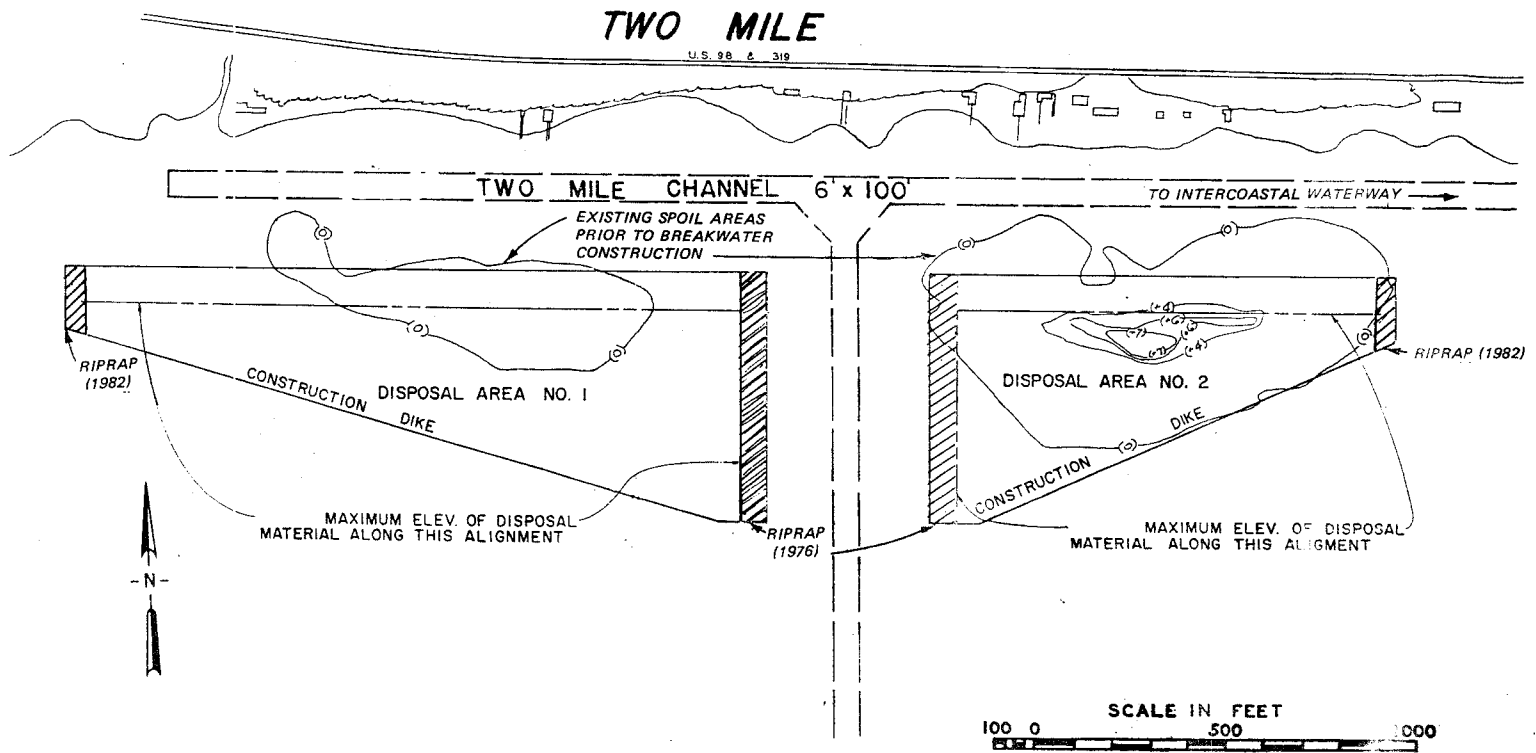
Figure 45. Two Mile breakwaters, Florida

Date(s)	Construction and Rehabilitation History
1976	<p>Two breakwaters retaining dredged materials were constructed on either side of the entrance channel to Two Mile Channel (Figures 43 and 45). The breakwaters were constructed parallel to, and 465 ft seaward of, the Two Mile Channel centerline. Prior to construction, elevations from -2 to +10 ft and -2 to +2 ft existed on the east and west sides, respectively. These areas had been built up from the material obtained from dredging of the existing channels. Both L-shaped breakwaters had 810-ft-long sections facing the entrance channel and 1,685- and 2,685-ft-long sections on the east and west sides, respectively, parallel to Two Mile Channel. The design section was to be built to +7 ft mlw with a 30-ft crown width and 1-V:10-H side slopes. Because of the nature of the dredged material, construction dikes were built around the periphery to retain the dredged material, allowing excess water drainage and material consolidation. The construction dikes were built up from adjacent bottom material to a cross-section elevation of +6 ft mlw, a crown width of 5 ft, and side slopes of 1V:3H above +1.5 ft mlw and 1V:8H below. After completion of the breakwaters, the construction dikes were left in place, and the side slopes facing the entrance channel were revetted with filter fabric and rubble stone.</p>

1982	<p>The outer ends of the two breakwaters had been eroding and were revetted with stone left over from the original construction.</p>
1985	<p>The breakwaters are presently in good condition.</p>
